Pavement Principles

Part one of a three-part series

Protecting your pavement investment

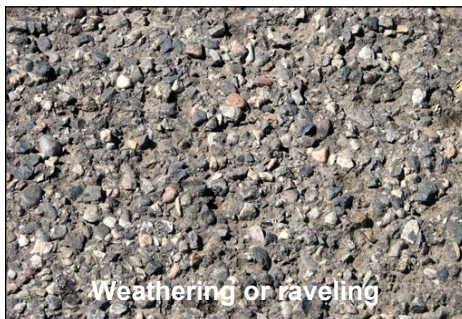
Weathering or raveling

Weathering or raveling can be the first sign of pavement deterioration. As the binder oxidizes, a pavement's fine aggregate components begin to wash away, revealing coarser aggregates. Eventually, the asphalt becomes rough and uneven.

Four common signs of pavement wear are clockwise from top left: raveling or weathering, block cracking, longitudinal cracking and alligator cracking. Knowing what causes each defect provides a better understanding of what maintenance or rehabilitation treatment is needed. Applying the right treatment at the right time will extend pavement life and pro-

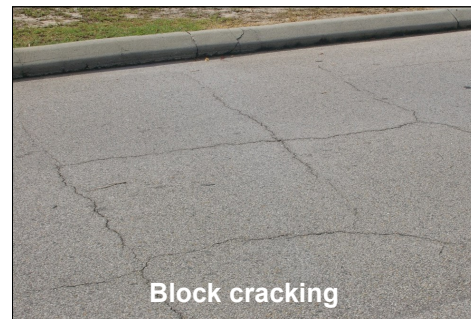
Block cracking

Block cracking, which is a combination of longitudinal and transverse cracking, has a distinctive checker-board pattern. Generally, it results as the binding agent evaporates and asphalt hardens and shrinks.

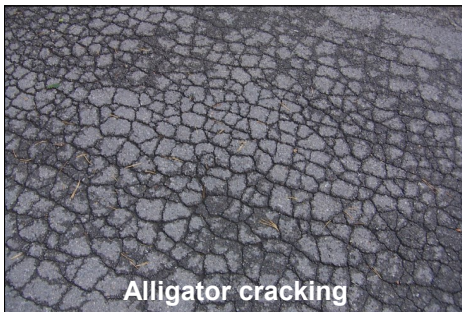
Alligator cracking

Alligator cracking is a series of inter-connecting cracks in the surface of asphalt pavement that looks like an alligator's hide. It may begin with a longitudinal crack under a wheel path, but repeated traffic loads cause the breakup of the surface layer. These cracks start on the bottom and work upward to the pavement's top surface. Alligator cracking is a clear sign of structural failure.

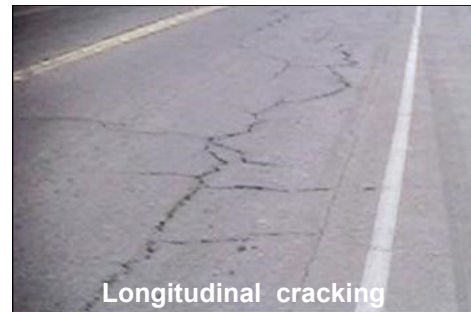
Longitudinal cracking

Longitudinal or transverse cracking runs parallel or perpendicular to the pavement's centerline. It results from environmental influences such as temperature and settlement or movement of the underlying layers and manifests itself in weak areas of the pavement such as paving joints.
